**Flood Control Project Maintenance
Levee Inspections**

2018 Channel Summary Report

Placer County

Truckee River

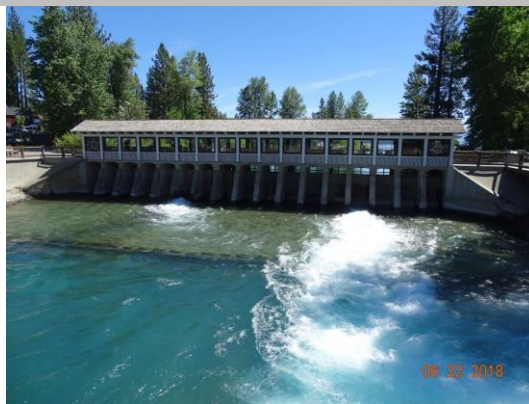
Photo 1 of 3 : CH_2018_NA0045_13_11_20180823_00028.jpg

Rating **	A	Issue No.	11	GPS Lat/Long
Issue Type +	Ma	Location *		39.166845 °
Category	Rivers, Channels & Designated Flood			-120.144424 °
Item	Vegetation & Obstructions			
DWR ID	DWR_NA0045_13_c_2012_11			
Action/Comments				
Inspector Comments: Minimal, scattered obstructions or vegetation. The flow is not impeded.

View of the river from Highway 89, looking upstream towards the outlet structure. Summer 2018.

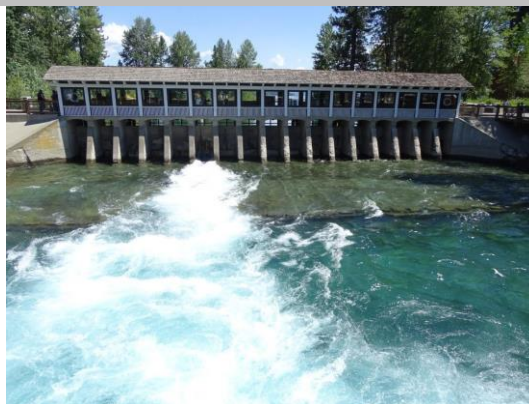
Photo 2 of 3 : CH_2018_NA0045_13_11_20180529_00001.jpg

View of the river from Highway 89, looking upstream towards the outlet structure. Summer 2017.

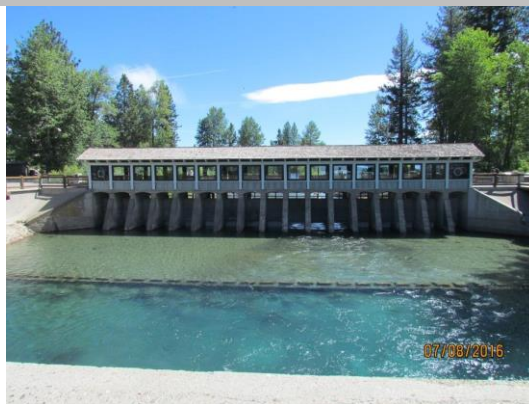
Photo 3 of 3 : CH_2018_NA0045_13_11_20180529_00002.jpg

Check Point / View				
Hwy 89 / Up (cont)				
Rating **	A	Issue No.	11 (cont)	GPS Lat/Long
Issue Type +	Ma	Location *		39.166845 °
Category	Rivers, Channels & Designated Flood			-120.144424 °
Item	Vegetation & Obstructions			
DWR ID	DWR_NA0045_13_c_2012_11			
Action/Comments				
Inspector Comments: Minimal, scattered obstructions or vegetation. The flow is not impeded.

View of the river from Highway 89 looking upstream towards the outlet structure. Summer 2016.

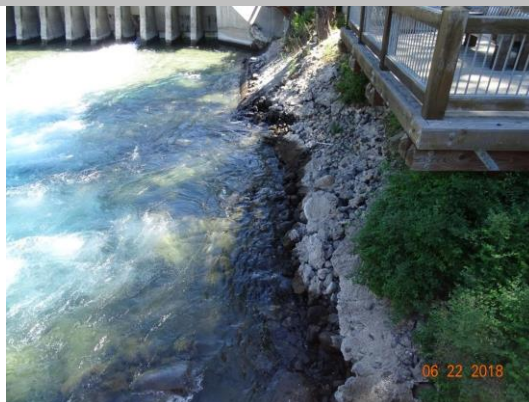
Photo 1 of 6 : CH_2018_NA0045_13_14_20180823_00024.jpg

Rating **	A	Issue No.	14	GPS Lat/Long
Issue Type +	Ma	Location *		39.166845 °
Category	Rivers, Channels & Designated Flood			-120.144424 °
Item	Revetments			
DWR ID	DWR_NA0045_13_c_2012_14			
Action/Comments				
Inspector Comments: Monitor scouring of revetment on the slope of the left bank.

View of revetment scour just upstream of the dam. Summer 2018.

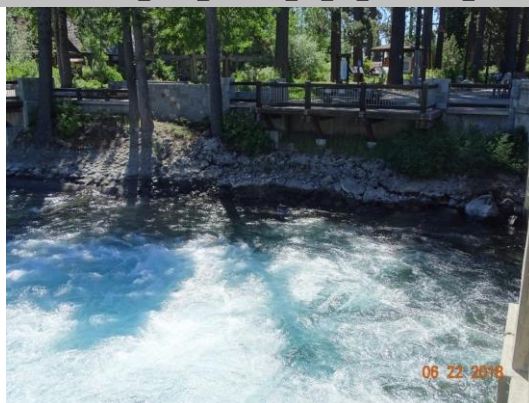
Photo 2 of 6 : CH_2018_NA0045_13_14_20180823_00026.jpg

Additional view of scouring on the left bank. Summer 2018.

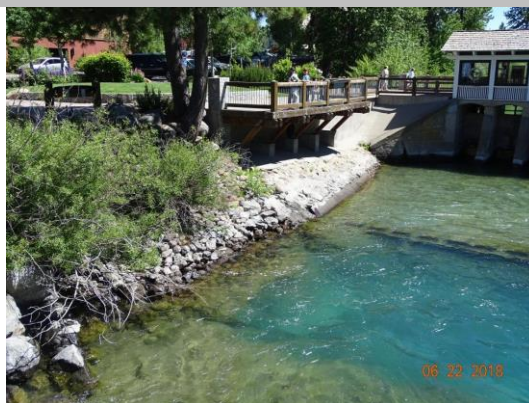
Photo 3 of 6 : CH_2018_NA0045_13_14_20180823_00027.jpg

View of the right bank just upstream of the dam. Summer 2018.

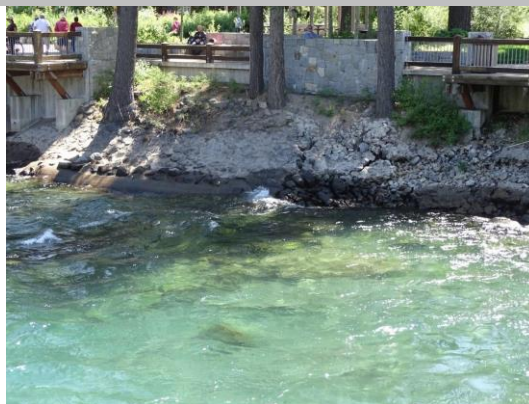
Photo 4 of 6 : CH_2018_NA0045_13_14_20180529_00003.jpg

Rating **	A	Issue No.	14 (cont)	GPS Lat/Long
Issue Type +	Ma	Location *		39.166845 °
Category	Rivers, Channels & Designated Flood			-120.144424 °
Item	Revetments			
DWR ID	DWR_NA0045_13_c_2012_14			
Action/Comments				
Inspector Comments: Monitor scouring of revetment on the slope of the left bank.

View of revetment scouring on left bank of the Truckee River. Summer 2017.

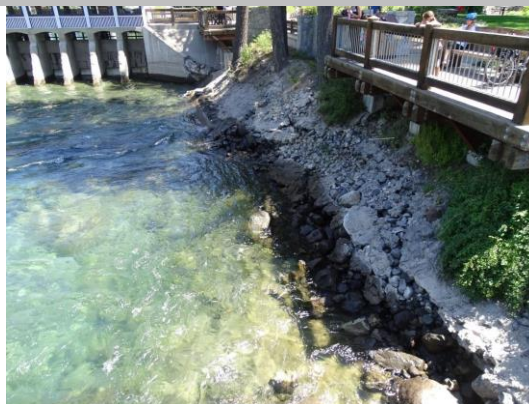
Photo 5 of 6 : CH_2018_NA0045_13_14_20180529_00004.jpg

Another view of the revetment scouring. Summer 2017.

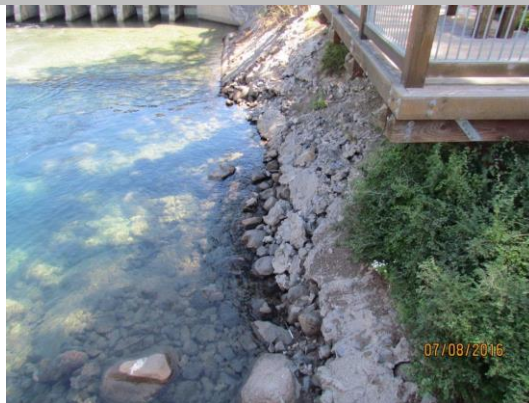
Photo 6 of 6 : CH_2018_NA0045_13_14_20180529_00005.jpg

Revetments are starting to show signs of scouring. Monitor revetments. Summer 2016.

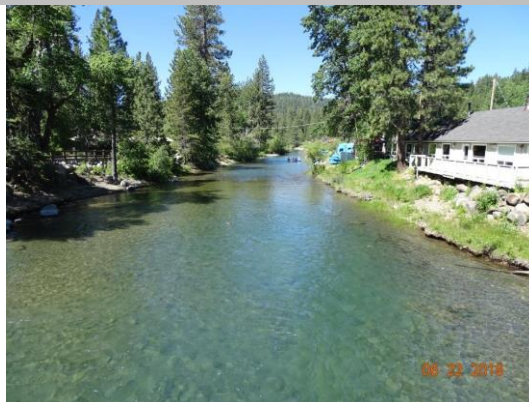
Photo 1 of 3 : CH_2018_NA0045_13_16_20180823_00022.jpg

Rating **	A	Issue No.	16	GPS Lat/Long
Issue Type +	Ma	Location *		39.166845 °
Category	Rivers, Channels & Designated Flood			-120.144424 °
Item	Vegetation & Obstructions			
DWR ID	DWR_NA0045_13_c_2012_16			
Action/Comments				
Inspector Comments: Minimal, scattered obstructions or vegetation. The flow is not impeded.

Looking downstream on the Truckee River from Highway 89. Summer 2018.

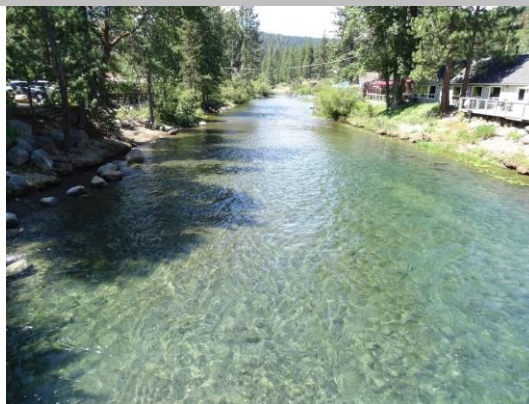
Photo 2 of 3 : CH_2018_NA0045_13_16_20180529_00006.jpg

Inspector Comments: Minimal, scattered obstructions or vegetation. The flow is not impeded.

Looking downstream on the Truckee River from Highway 89. Summer 2017.

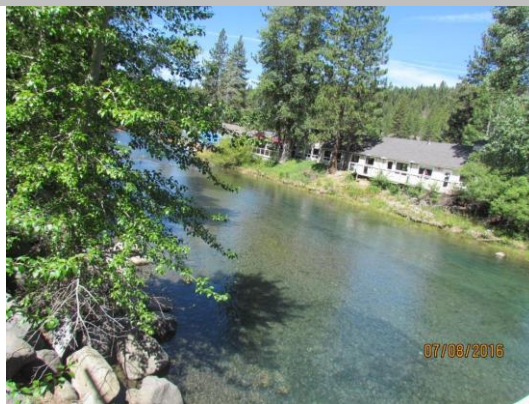
Photo 3 of 3 : CH_2018_NA0045_13_16_20180529_00007.jpg

View of the river looking downstream from Highway. Summer 2016.

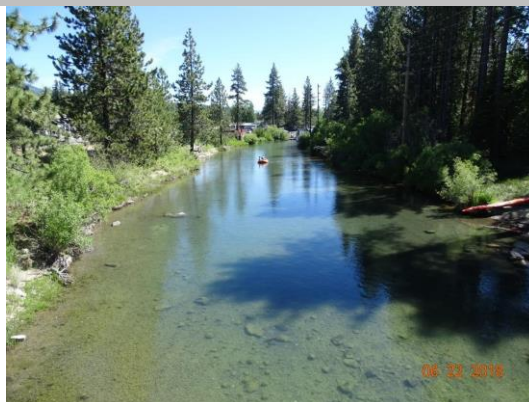
Photo 1 of 3 : CH_2018_NA0045_13_21_20180823_00021.jpg

Rating **	A	Issue No.	21	GPS Lat/Long
Issue Type +	Ma	Location *		39.165170 °
Category	Rivers, Channels & Designated Flood			-120.147590 °
Item	Vegetation & Obstructions			
DWR ID	DWR_NA0045_13_c_2012_21			
Action/Comments				
Inspector Comments: Minimal, scattered obstructions or vegetation. The flow is not impeded.

View of the Truckee River, looking upstream from the bike bridge. Summer 2018.

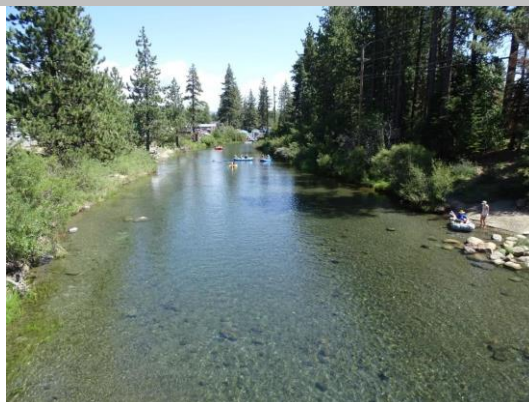
Photo 2 of 3 : CH_2018_NA0045_13_21_20180529_00008.jpg

View of the Truckee River, looking upstream from the bike bridge. Summer 2017.

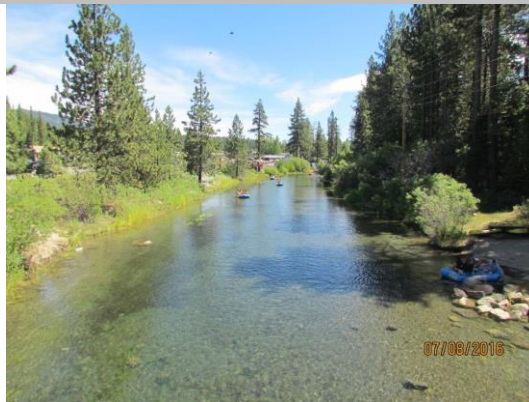
Photo 3 of 3 : CH_2018_NA0045_13_21_20180529_00009.jpg

View of the river looking upstream from the bike bridge. Summer 2016.

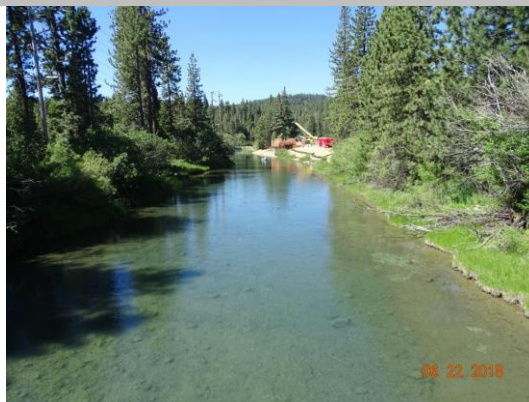
Photo 1 of 3 : CH_2018_NA0045_13_26_20180823_00020.jpg

Inspector Comments: Minimal, scattered obstructions or vegetation. The flow is not impeded.

View of the Truckee River, looking downstream from the bike bridge.
Summer 2018.

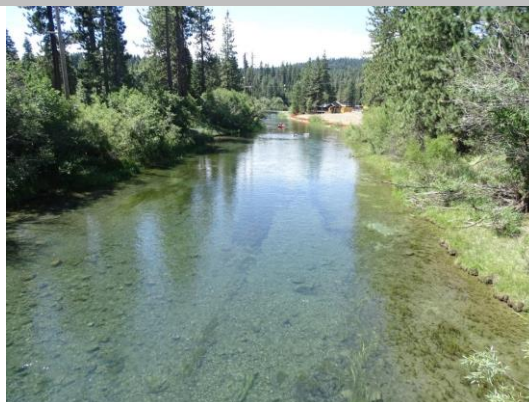
Photo 2 of 3 : CH_2018_NA0045_13_26_20180529_00010.jpg

Rating **	A	Issue No.	26 (cont)	GPS Lat/Long
Issue Type +	Ma	Location *		39.165170 °
Category	Rivers, Channels & Designated Flood			-120.147590 °
Item	Vegetation & Obstructions			
DWR ID	DWR_NA0045_13_c_2012_26			
Action/Comments				
Inspector Comments: Minimal, scattered obstructions or vegetation. The flow is not impeded.

View of the Truckee River, looking downstream from the bike bridge. Summer 2017.

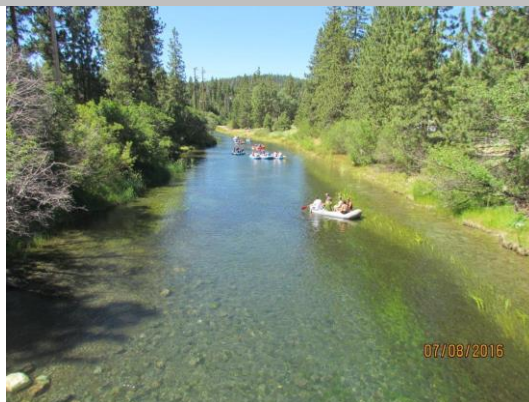
Photo 3 of 3 : CH_2018_NA0045_13_26_20180529_00011.jpg

View of the river looking down from the bike bridge. Summer 2016.

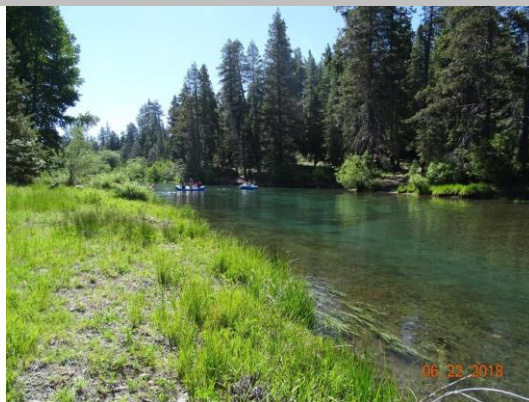
Photo 1 of 4 : CH_2018_NA0045_13_31_20180823_00019.jpg

Inspector Comments: Minimal, scattered obstructions or vegetation. The flow is not impeded.

View of the Truckee River, looking upstream from the Tahoe City Lumber Yard. Summer 2018.

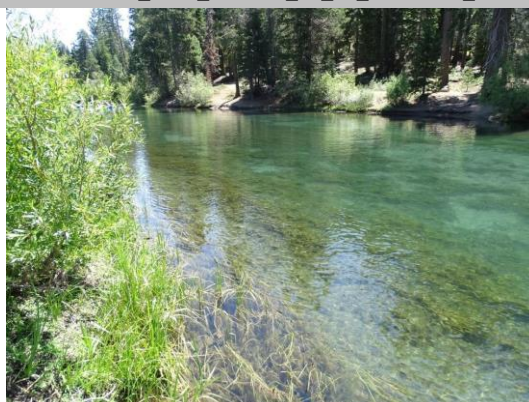
Photo 2 of 4 : CH_2018_NA0045_13_31_20180529_00012.jpg

View of the Truckee River, looking upstream from the Tahoe City Lumber Yard. Summer 2017.

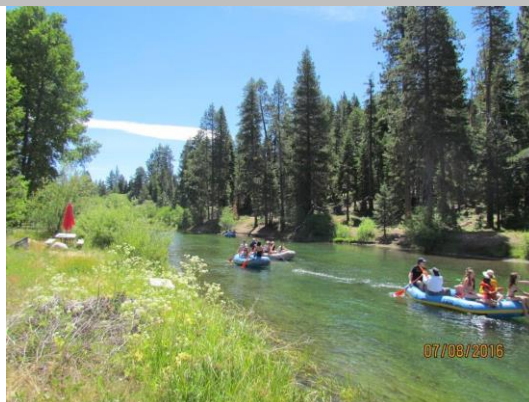
Photo 3 of 4 : CH_2018_NA0045_13_31_20180529_00013.jpg

Inspector Comments: Minimal, scattered obstructions or vegetation. The flow is not impeded.

View of the river looking upstream from Tahoe City Lumber Yard. Summer 2016.

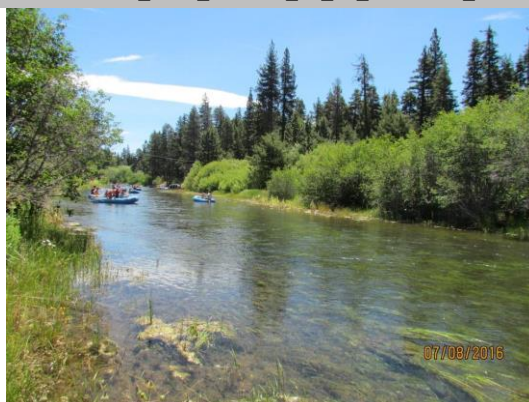
Photo 4 of 4 : CH_2018_NA0045_13_31_20180529_00014.jpg

View of the river looking upstream from Tahoe City Lumber Yard. Summer 2016.

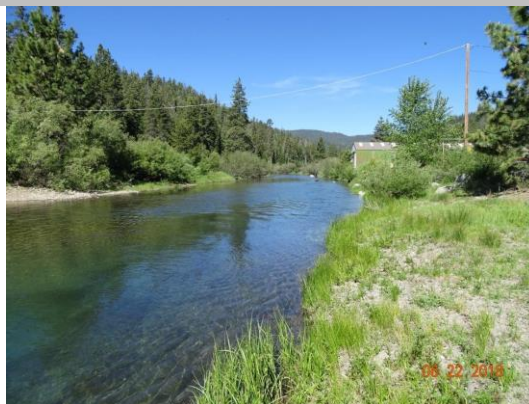
Photo 1 of 4 : CH_2018_NA0045_13_36_20180823_00018.jpg

Rating **	A	Issue No.	36	GPS Lat/Long
Issue Type +	Ma	Location *		39.162480 °
Category	Rivers, Channels & Designated Flood			-120.151900 °
Item	Vegetation & Obstructions			
DWR ID	DWR_NA0045_13_c_2012_36			
Action/Comments				
Inspector Comments: Minimal, scattered obstructions or vegetation. The flow is not impeded.

View of the Truckee River, looking downstream from the Tahoe City Lumber Yard. Summer 2018.

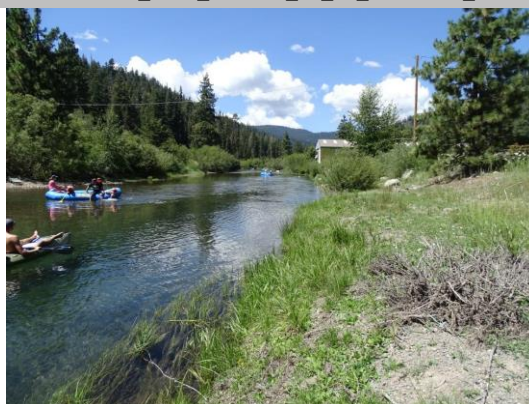
Photo 2 of 4 : CH_2018_NA0045_13_36_20180529_00015.jpg

View of the Truckee River, looking downstream from the Tahoe City Lumber Yard. Summer 2017.

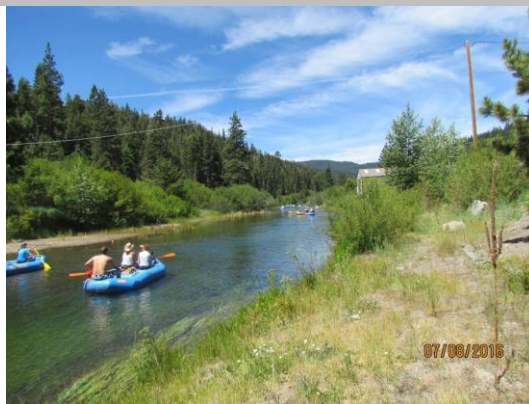
Photo 3 of 4 : CH_2018_NA0045_13_36_20180529_00016.jpg

Rating **	A	Issue No.	36 (cont)	GPS Lat/Long
Issue Type +	Ma	Location *		39.162480 °
Category	Rivers, Channels & Designated Flood			-120.151900 °
Item	Vegetation & Obstructions			
DWR ID	DWR_NA0045_13_c_2012_36			
Action/Comments				
Inspector Comments: Minimal, scattered obstructions or vegetation. The flow is not impeded.

View of the river looking downstream from Tahoe City Lumber Yard.
Summer 2016.

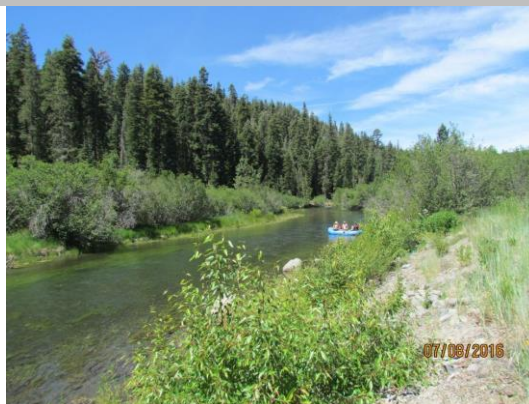
Photo 4 of 4 : CH_2018_NA0045_13_36_20180529_00017.jpg

View of the river looking downstream from Tahoe City Lumber Yard.
Summer 2016.
